Belmont Lake Dam, NDS ID PA.-00163,
DER ID 64-21. Delaware River Basin,
W. Branch Lackawaxen River, Wayne County,
Pennsylvania. Phase I Inspection Report.

BELMONT LAKE DAM
WAYNE COUNTY, PENNSYLVANIA

NDS I.D. NO. PA 00163
DER I.D. NO. 64-21

PHASE I INSPECTION REPORT
NATIONAL DAM INSPECTION PROGRAM

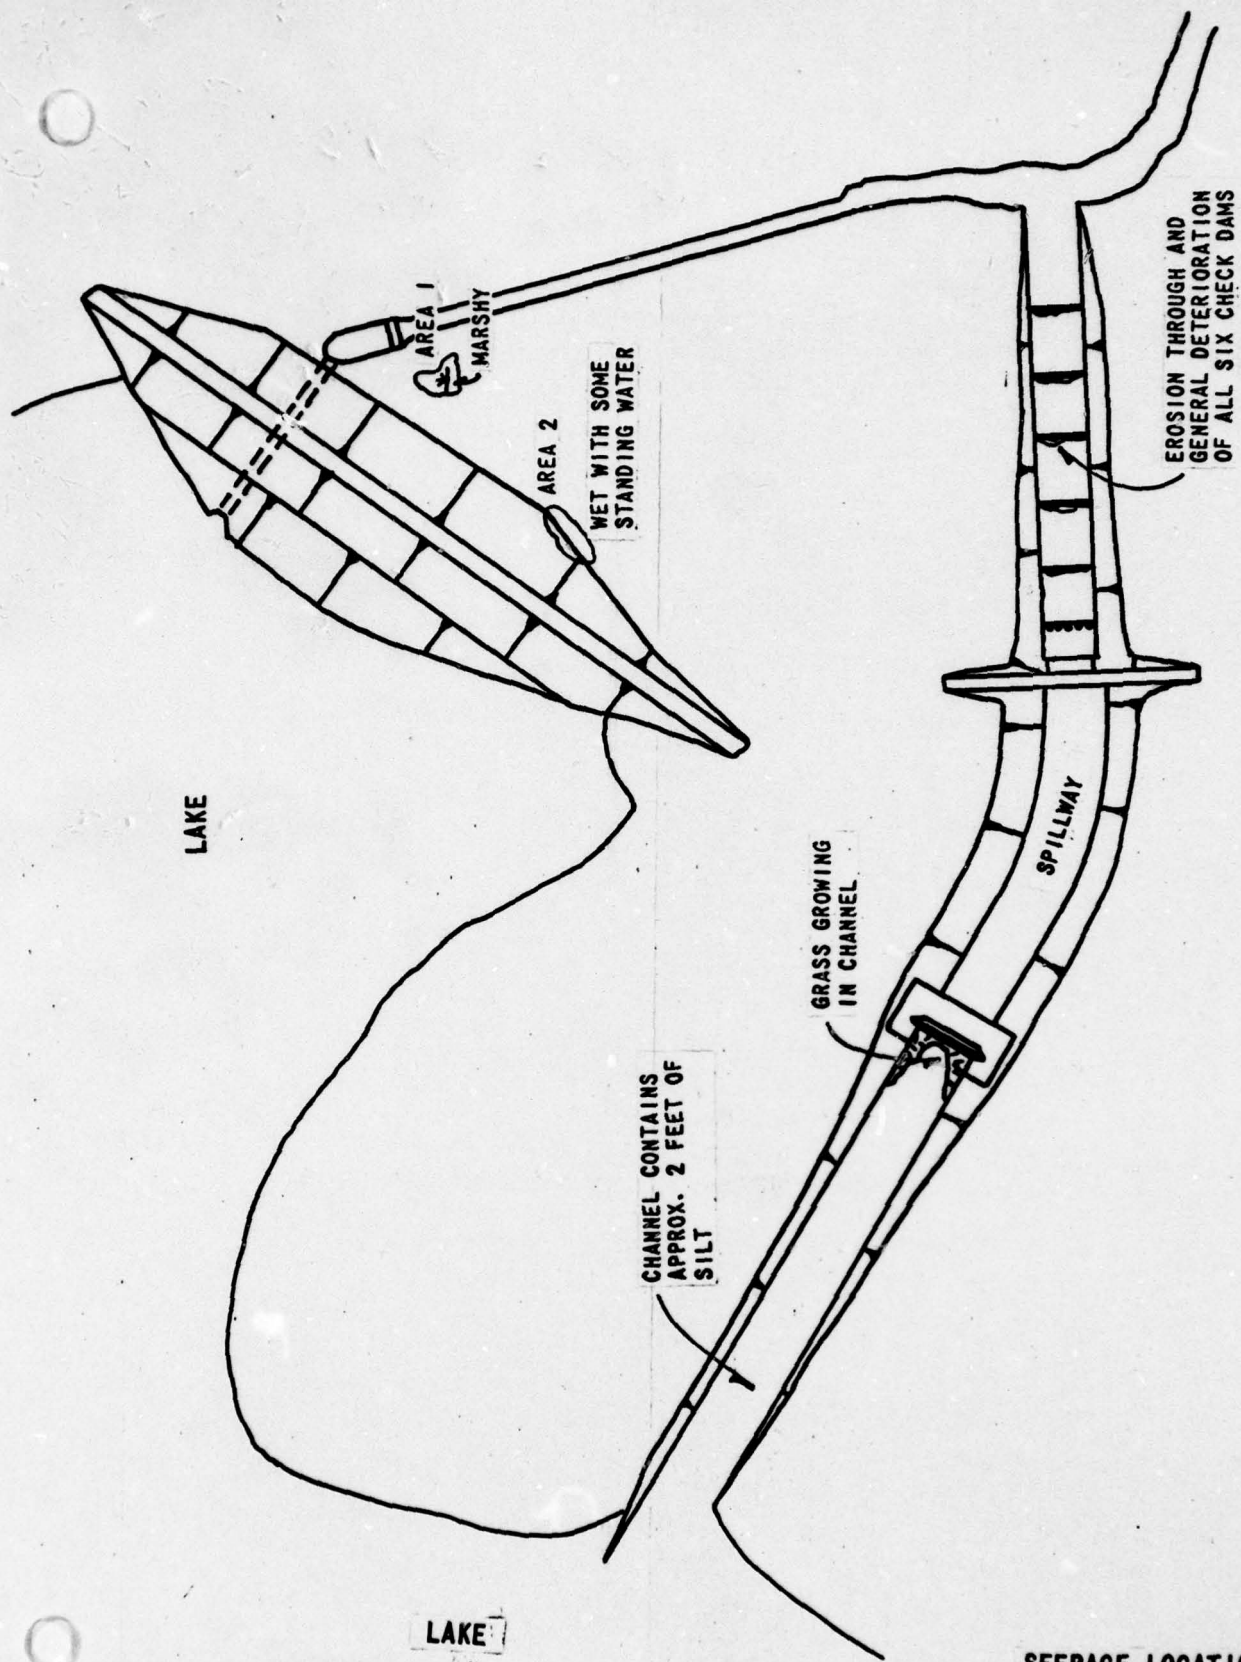
SHEET 5a OF 11

As delineated on Sheet 5a, Appendix B, there were two wet areas noted on the downstream side of the embankment below the toe and to the right of the principal spillway. Area No. 1 is considered to be a topographic low which temporarily retards water after a rainfall. Area No. 2 is considered to be associated with seepage emergence. As a spring house once existed in this area, the possibility of springs cannot be discounted.

The two wet areas located downstream of the dam are assessed to be a topographic low and a natural spring, respectively. There was no evidence of discolored seepage indicative of piping processes or of progressively increasing seepage flows. The exposed portions of the intake riser were inspected and judged to be in good condition.

The wet areas, noted on Sheet 5a of Appendix B, downstream of the embankment and to the right of the principal spillway discharge channel were assessed to be associated with a topographic low and seepage emergence (perhaps due to a natural spring), respectively. The seepage emergence was clear, and there is evidence that the condition is stable.

There were two wet areas noted on the downstream side of the embankment below the toe and to the right of the principal spillway. See Sheet 5a. Area number 1 is considered a topographic low and area number 2 is considered to be a spring (seepage) area. Area No. 2 should be stabilized and drained.

1. Seepage Area No. 2 should be drained and stabilized.
2. The flow rate and turbidity from Area 2 should be periodically monitored and recorded. If flow significantly increases, necessary remedial action should be taken.
3. The check dams should be repaired.
4. The silt accumulations in the approach channel to the emergency spillway should be monitored. When the depth of the silt is great enough to impede the discharge capacity, the channel should be dredged.
5. Consideration should also be given to improving the access road over the spillway channel since it is highly susceptible to flooding.

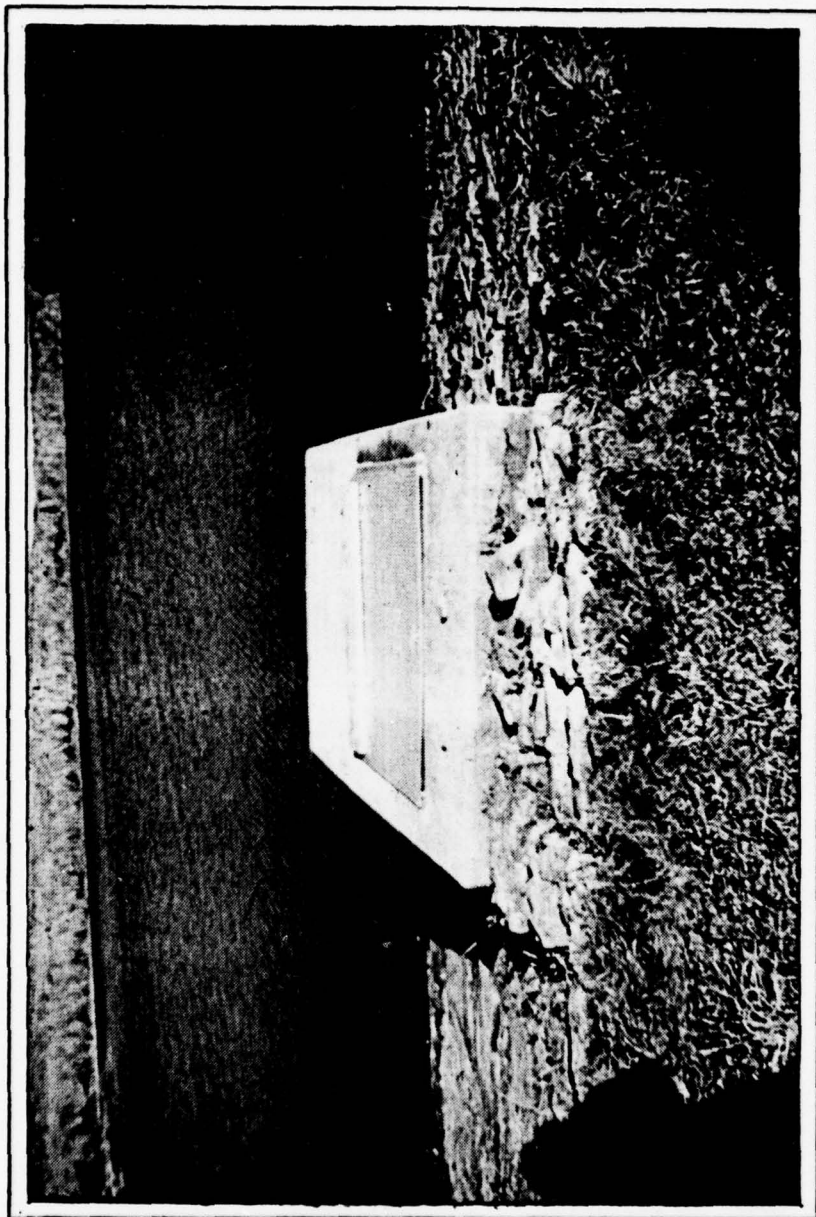
PHOTOGRAPH NO. 1

PRINCIPAL SPILLWAY RISER.

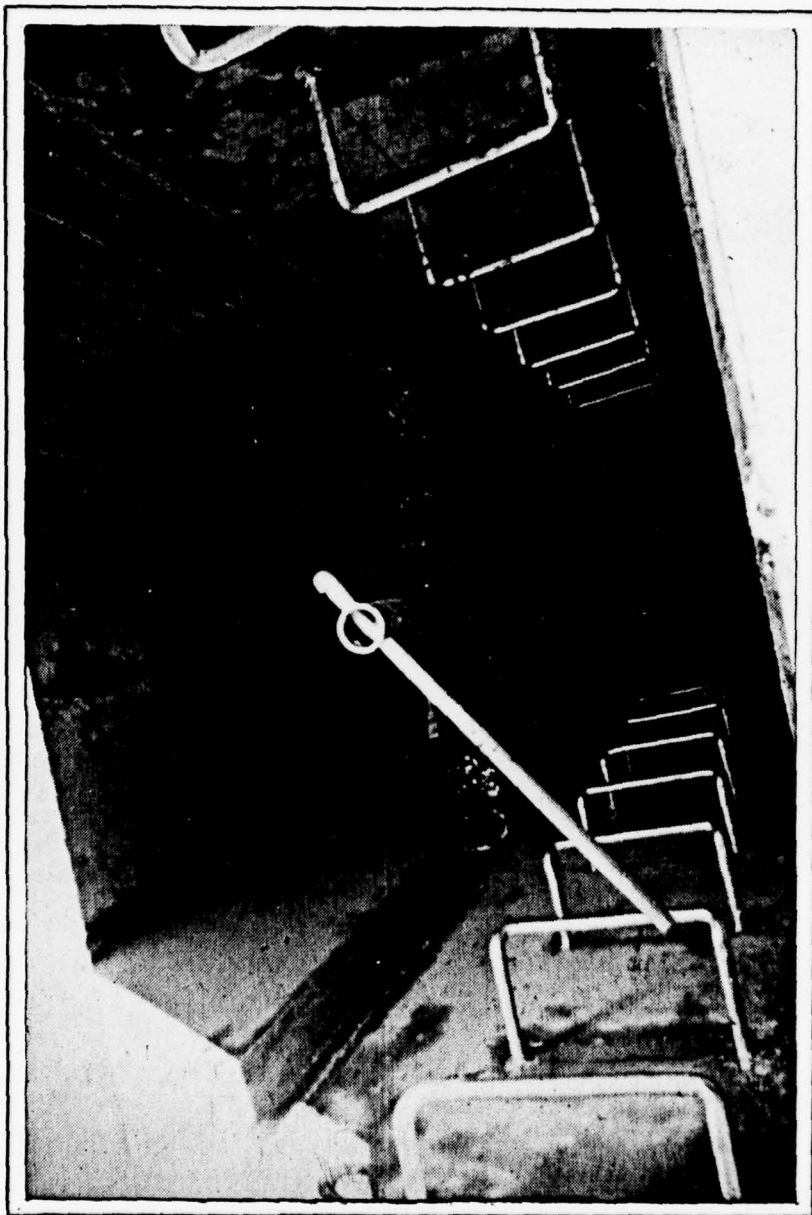
INTERIOR VIEW OF RISER. NOTE WOOD
STOP LOGS AND VALVE HANDLE FOR POND
DRAIN.

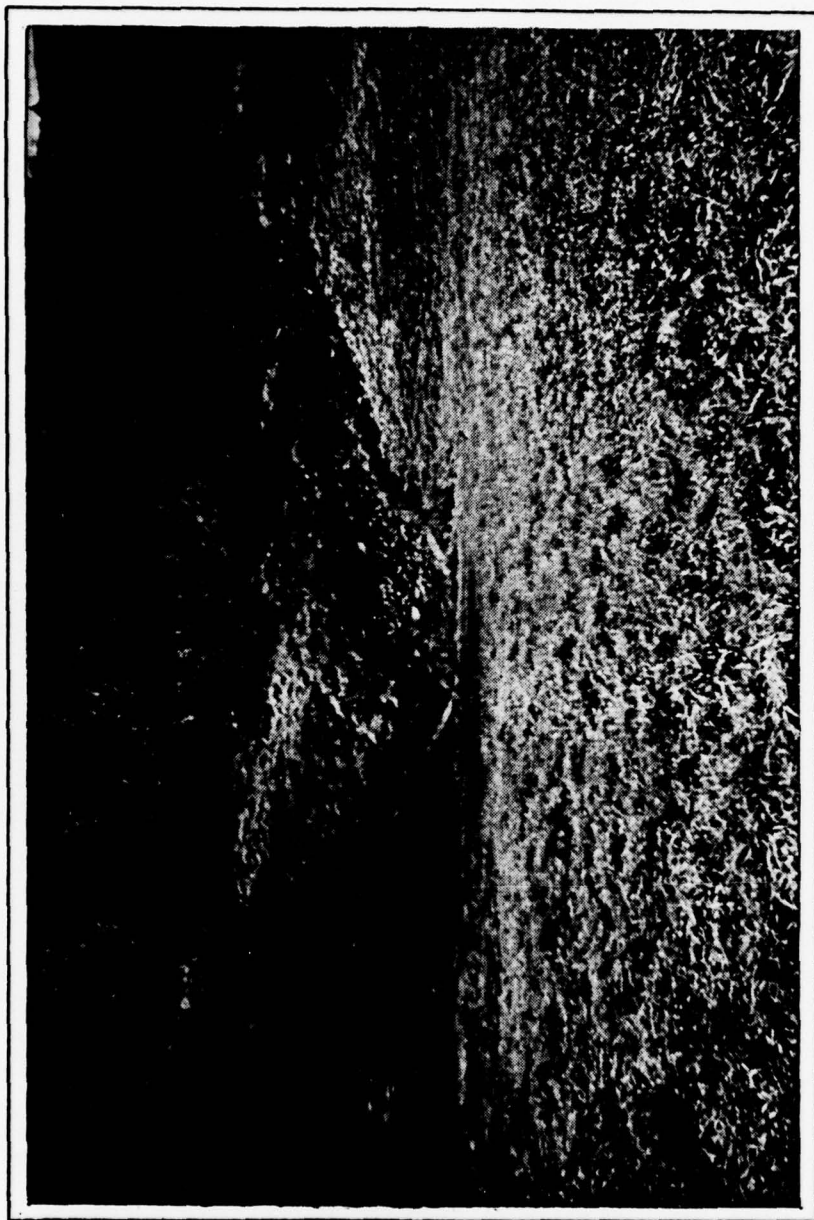
OVERVIEW OF DISCHARGE CHANNEL BELOW
PRINCIPAL SPILLWAY.

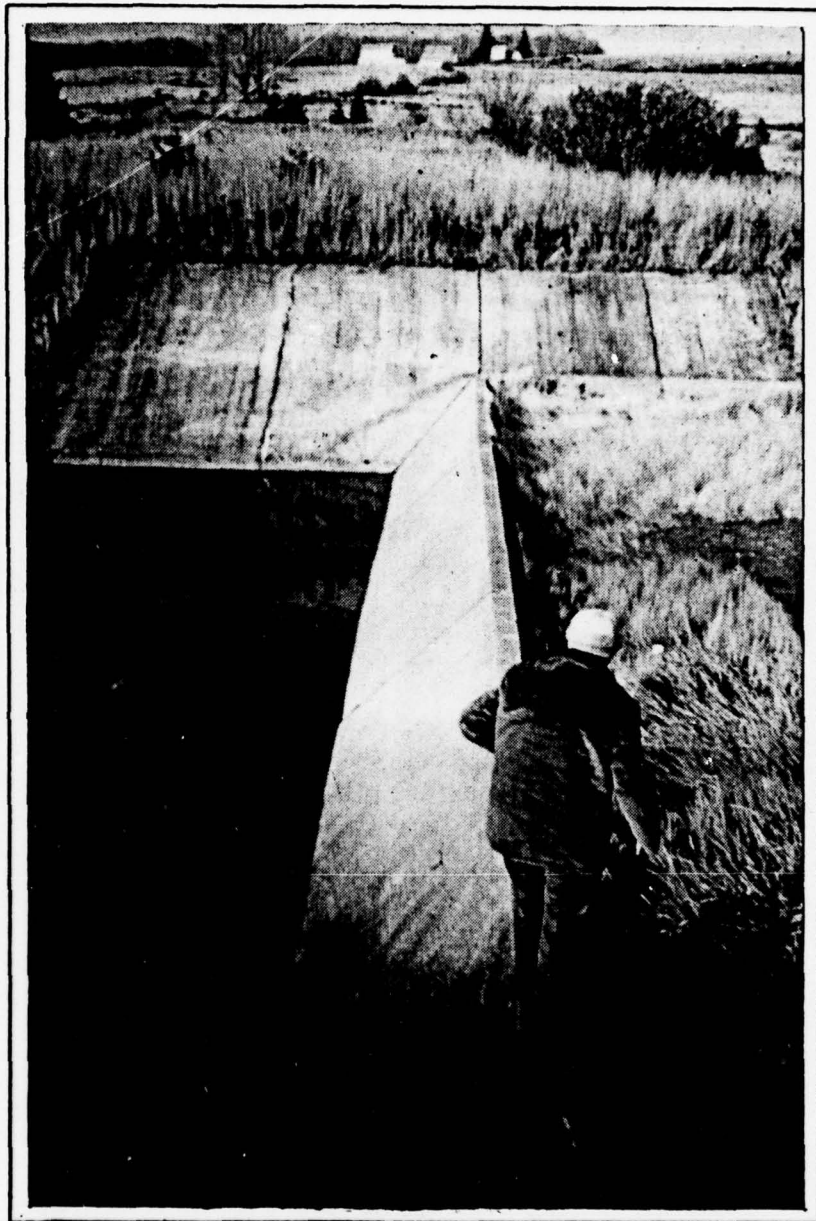
PHOTOGRAPH NO. 5

2. Emergency Spillway. The riprap-lined approach channel, trapezoidal concrete weir, and stilling basin are all considered to be in good condition with no significant signs of riprap deterioration, concrete spalling or general concrete deterioration.

OVERVIEW OF TRAPAZOIDAL
WEIR OF EMERGENCY SPILLWAY
LOOKING TOWARDS RIGHT
ABUTMENT.

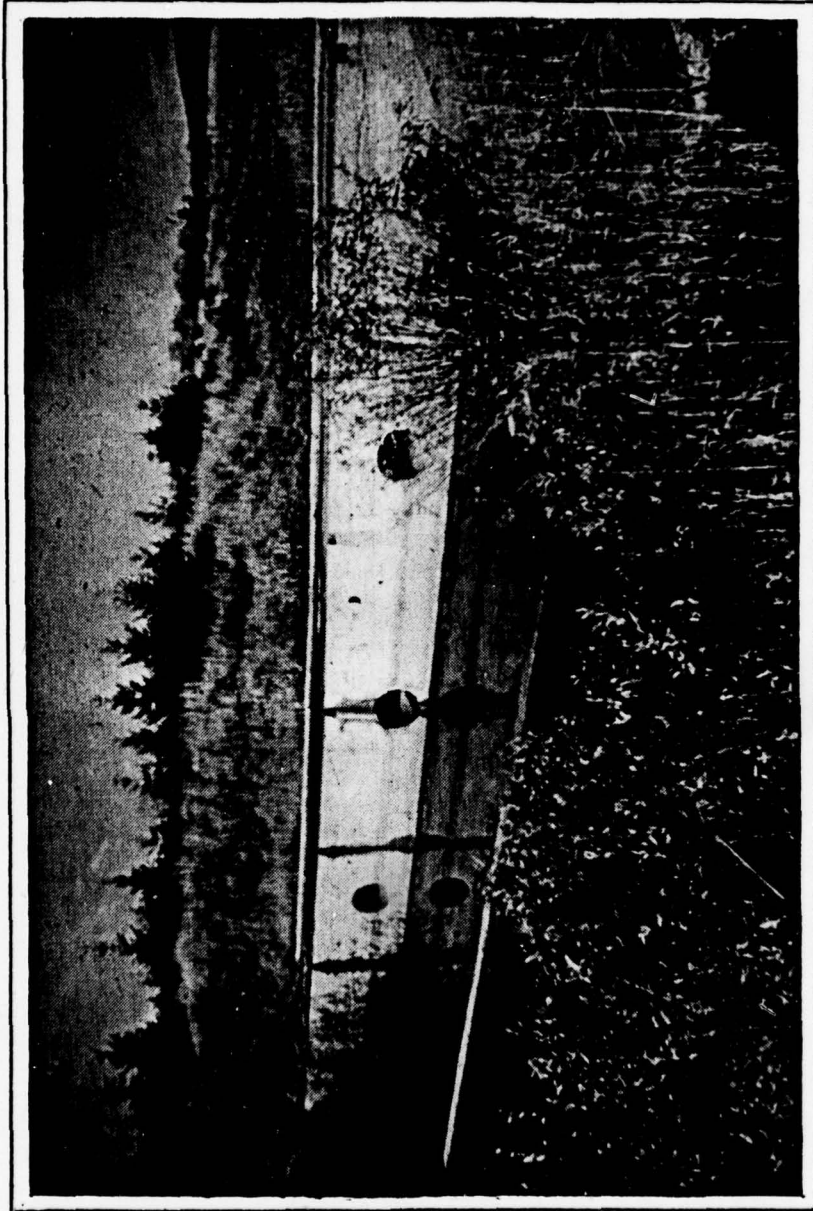
The discharge channel below the access road contains six rock check dams which were judged to be in poor condition and in a state of disrepair. These can be seen in the photographs presented in Appendix D. These dams were installed to dissipate the energy of the discharging water before it enters the West Branch of the Lackawaxen River. The dams still function to reduce the energy of the water before entering the creek; although, unless repaired, it is only a matter of time before they will cease to function effectively. The access bridge, or ford, containing the three 24-inch diameter culverts was inspected and found to be in good condition. However, due to the fact that there are only three 24-inch diameter pipes, it is expected that water would pond behind the roadway and, during severe storms, inundate this roadway, preventing access to the dam. These culverts are also susceptible to clogging.

DISCHARGE CONDUITS BENEATH ACCESS
ROAD SHOWN IN PHOTOGRAPH 6.

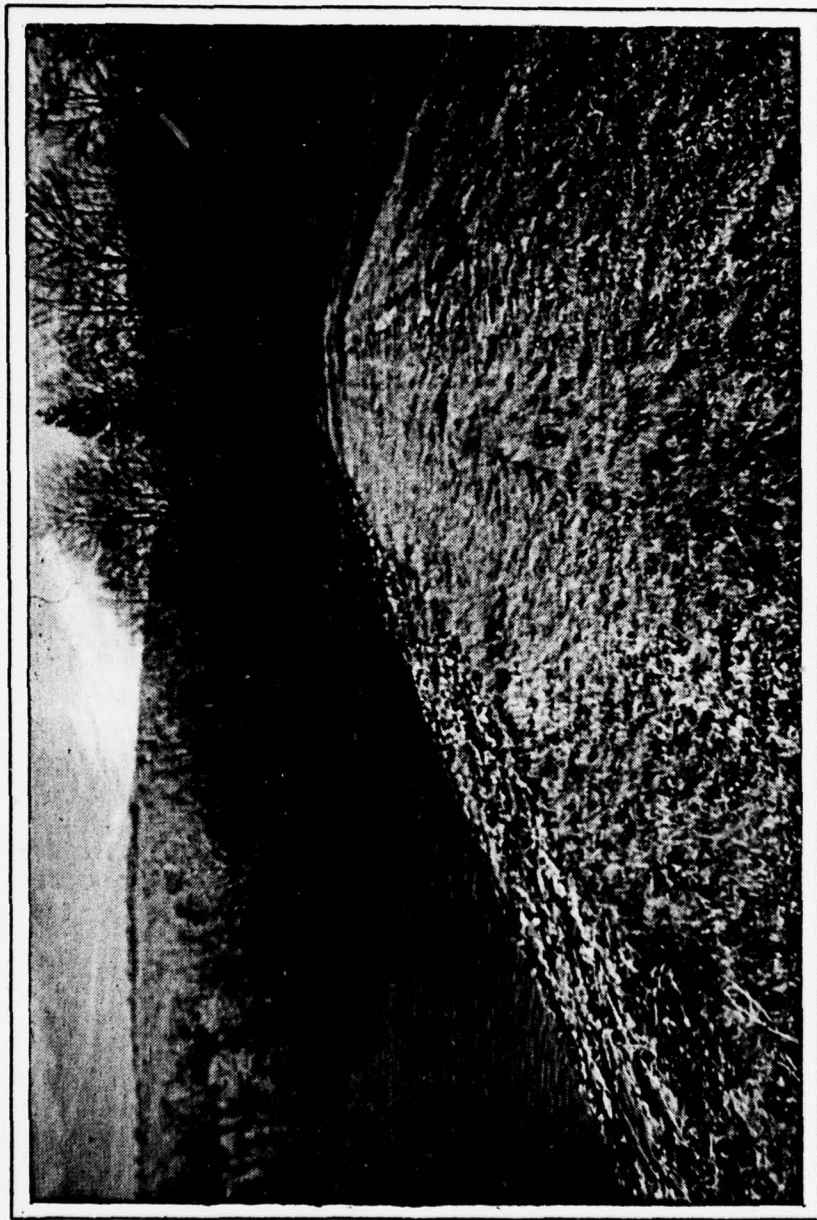
PHOTOGRAPH NO. 9

OVERVIEW OF CREST AND UPSTREAM SLOPE
LOOKING TOWARDS LEFT ABUTMENT.

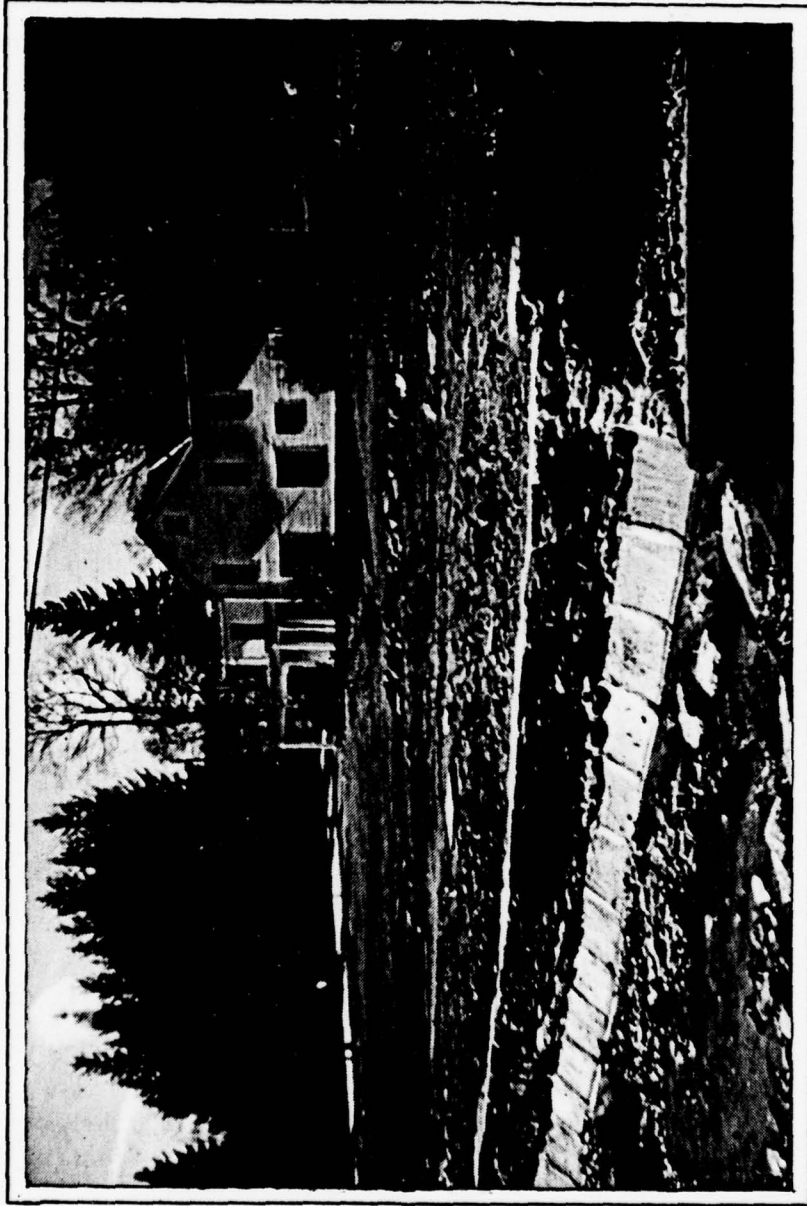
STREAM AS IT PASSES THROUGH FISH
HATCHERY APPROXIMATELY TWO MILES
DOWNSTREAM.
